QX COMPONENTS LTD

Technical Data Booklet

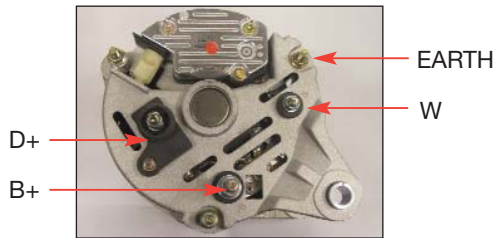
wiring of QA1452

The wiring on this alternator can be confusing.

When connecting the wiring on this type of alternator our QA1452 please ensure the earth terminal is connected to the tagged through bolt, do not connect to the W (phase) terminal.

Connection of earth to the W (phase) terminal will short circuit the unit and render it useless.

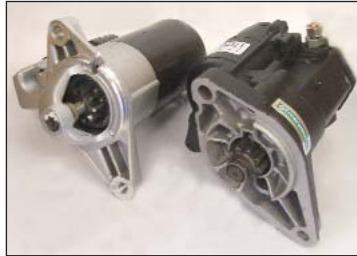
Japanes

A conventional looking type with a nose cone and open nose geared type

Although these different types do look completely different they do interchange
